Geotechnical Report

Geotechnical Investigation

Norann Subdivision Area Road Reconstruction

(MOA PM&E Project No. 20-14)

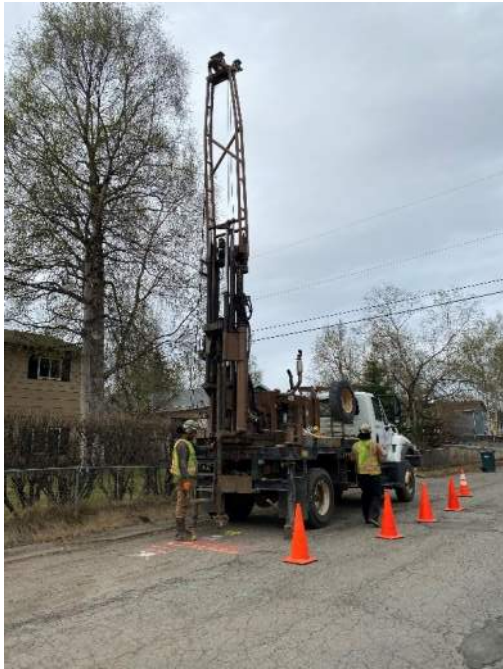
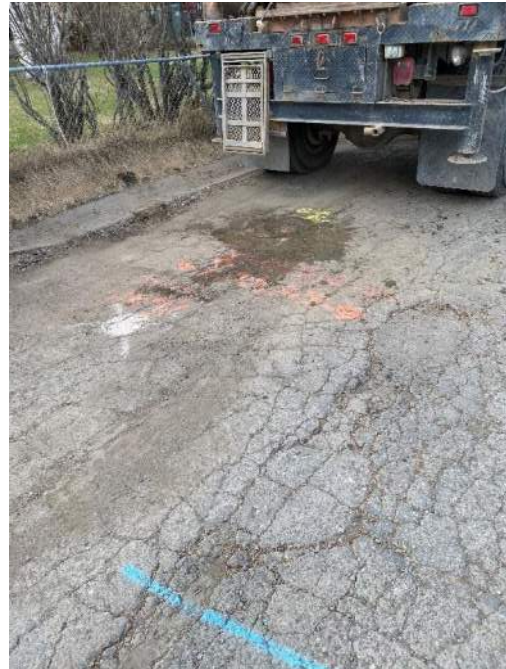
05/11/2021: Setting up rig on BH-01 with utility markings (left). Borehole marked with white paint. BH-01 after completion as a piezometer with flush-mount monument (right).

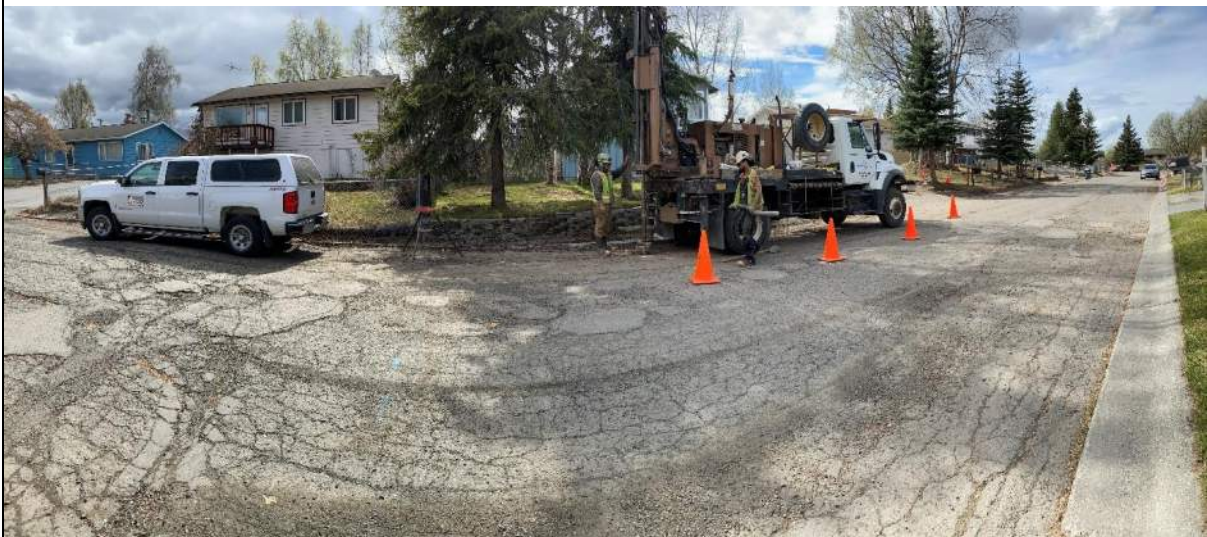
05/11/2021: Drill rig on BH-02 with utility markings prior to drilling. Borehole marked with white paint.

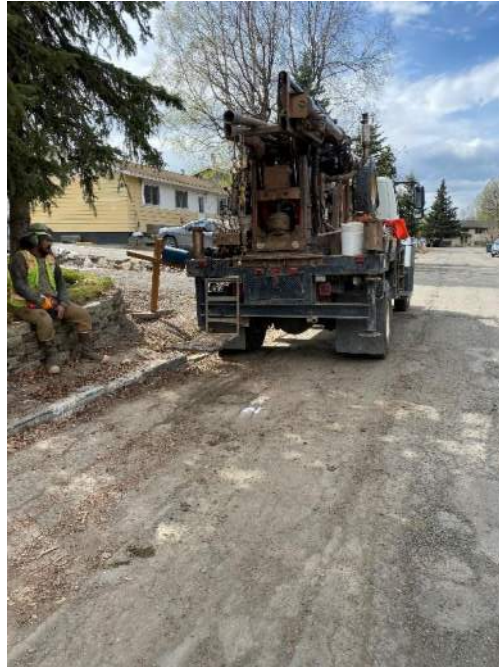
05/11/2021: BH-02 after completion of drilling and cold patch (no piezometer).

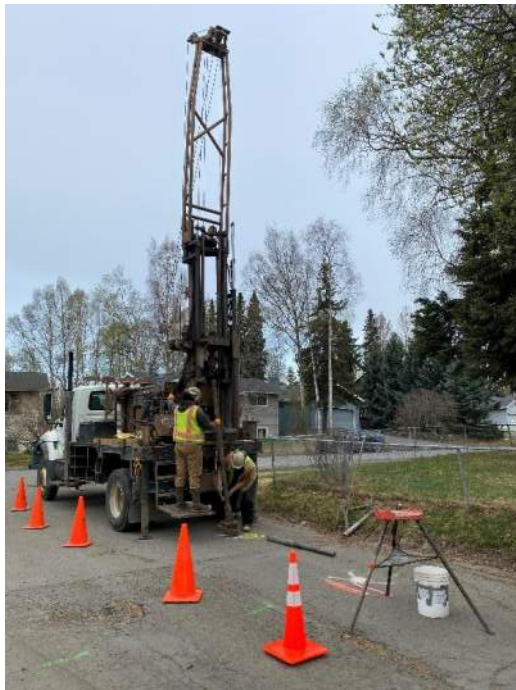
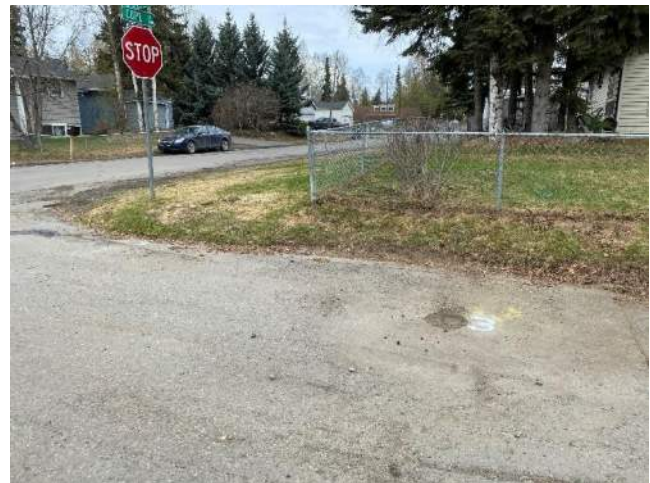
05/11/2021: Setting up rig on BH-03 with utility markings (left). Borehole marked with white paint. BH-03 after completion as a piezometer with flush-mount monument (right).

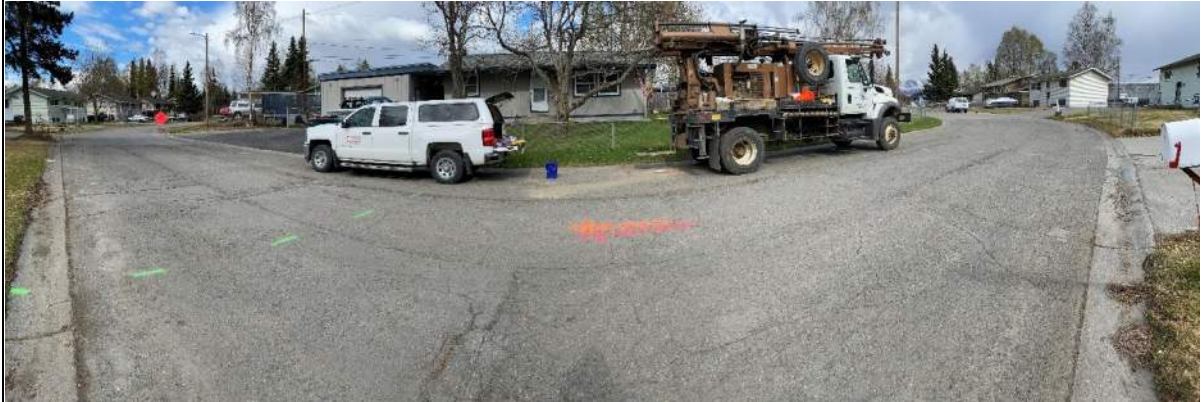
05/11/2021: BH-04 with utility markings prior to drilling. Borehole marked with white paint.

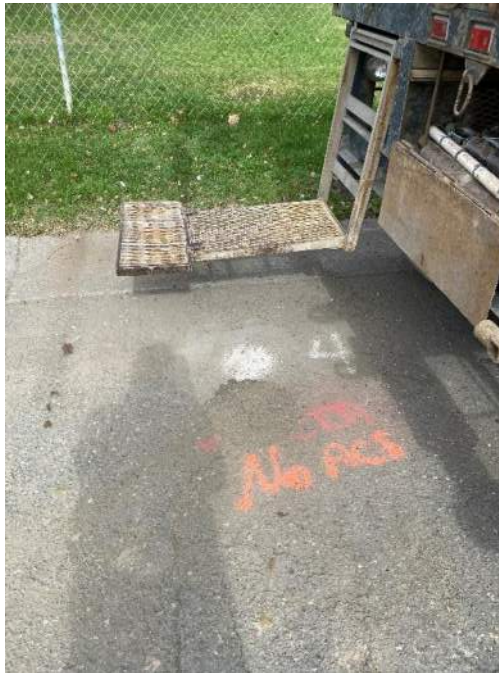
05/11/2021: BH-04 after drilling and completion. Backfilled and cold patched.

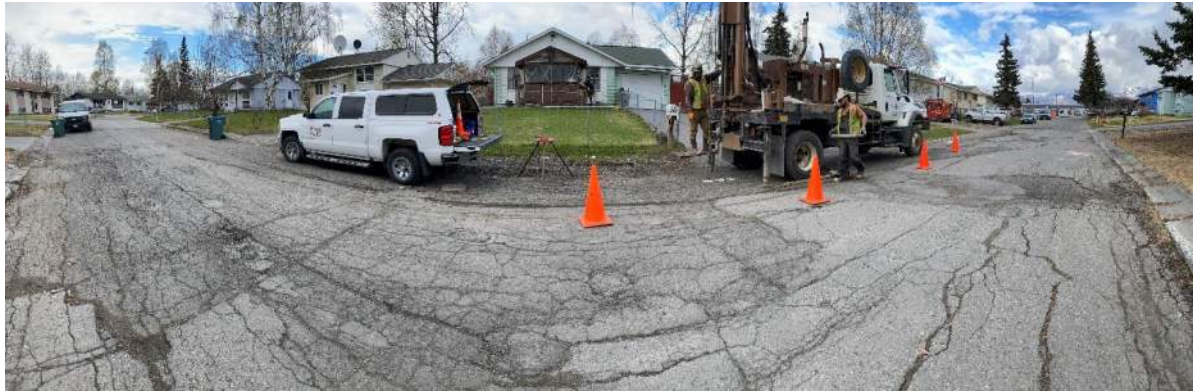
05/11/2021: BH-05 with utility markings prior to drilling Borehole marked with white paint.

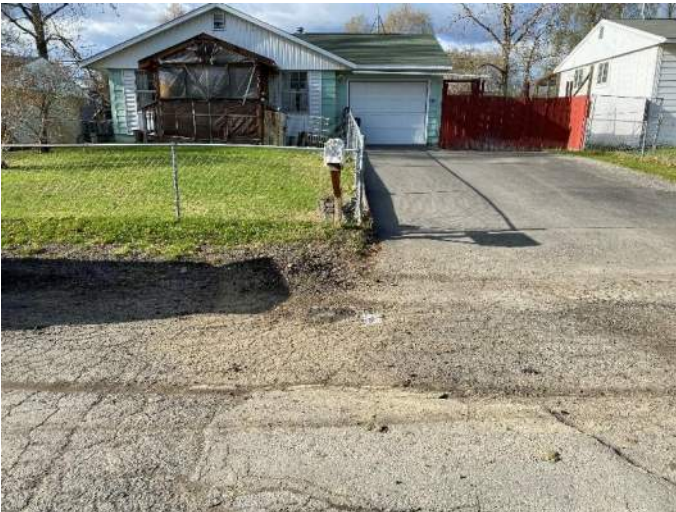
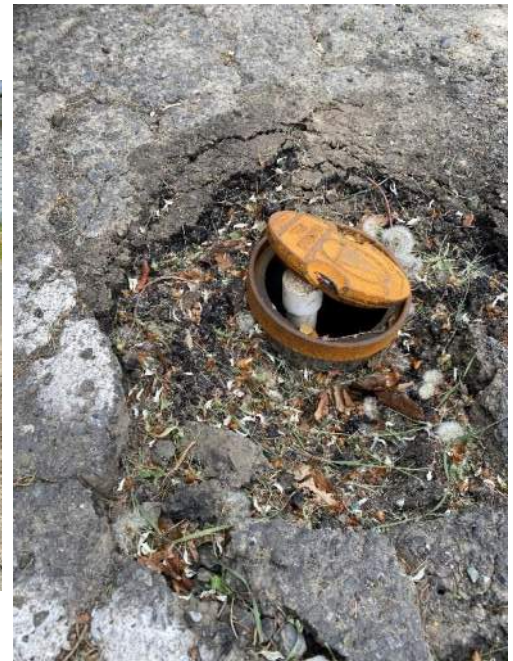
05/11/2021: BH-05 after completion as a piezometer with flush-mount monument (left). After approximately a month, ground had subsided around the monument and left the casing protruding above the lip of the monument (right). The casing was cut down so the monument lid could be closed.

Evidence of ground movement at BH-05 was observed when groundwater level readings were collected after drilling. The ground had subsided around the monument and left the casing protruding above the lip of the monument. The casing was cut down so the monument lid could be closed. The monument was replaced in September 2021 and the ground brought back to level to minimize the effect on traffic.

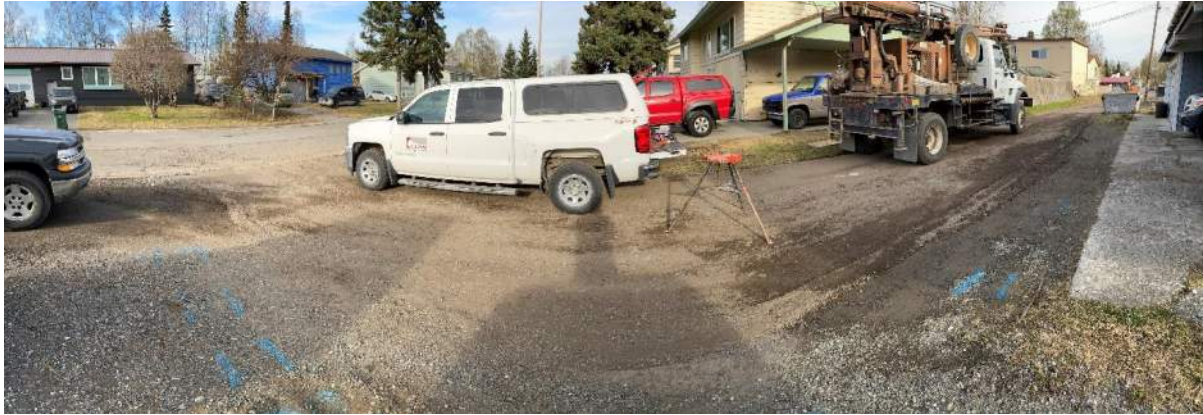
05/11/2021: BH-06 with utility markings prior to drilling. Borehole marked with white paint. Alleyway had been graded the day before drilling, eradicating previous markings in the road.

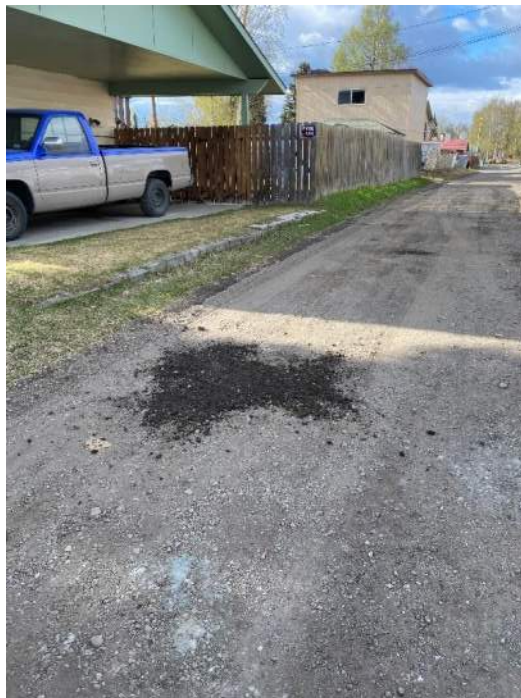
05/11/2021: BH-06 after completion. Hole was backfilled with cuttings from this hole and gravel was spread at surface and leveled.

All cuttings from BH-06 with a petroleum odor were disposed of at the borehole location. No other evidence of contamination was observed at any other boreholes.
